**(NAVY) NAVAIR 17-15-50.3
(ARMY) TM 38-301-3
(AIR FORCE) T.O. 33-1-37-3
(COAST GUARD) CGTO 33-1-37-3**

JOINT OIL ANALYSIS PROGRAM MANUAL

VOLUME III

LABORATORY ANALYTICAL METHODOLOGY AND EQUIPMENT CRITERIA (AERONAUTICAL)

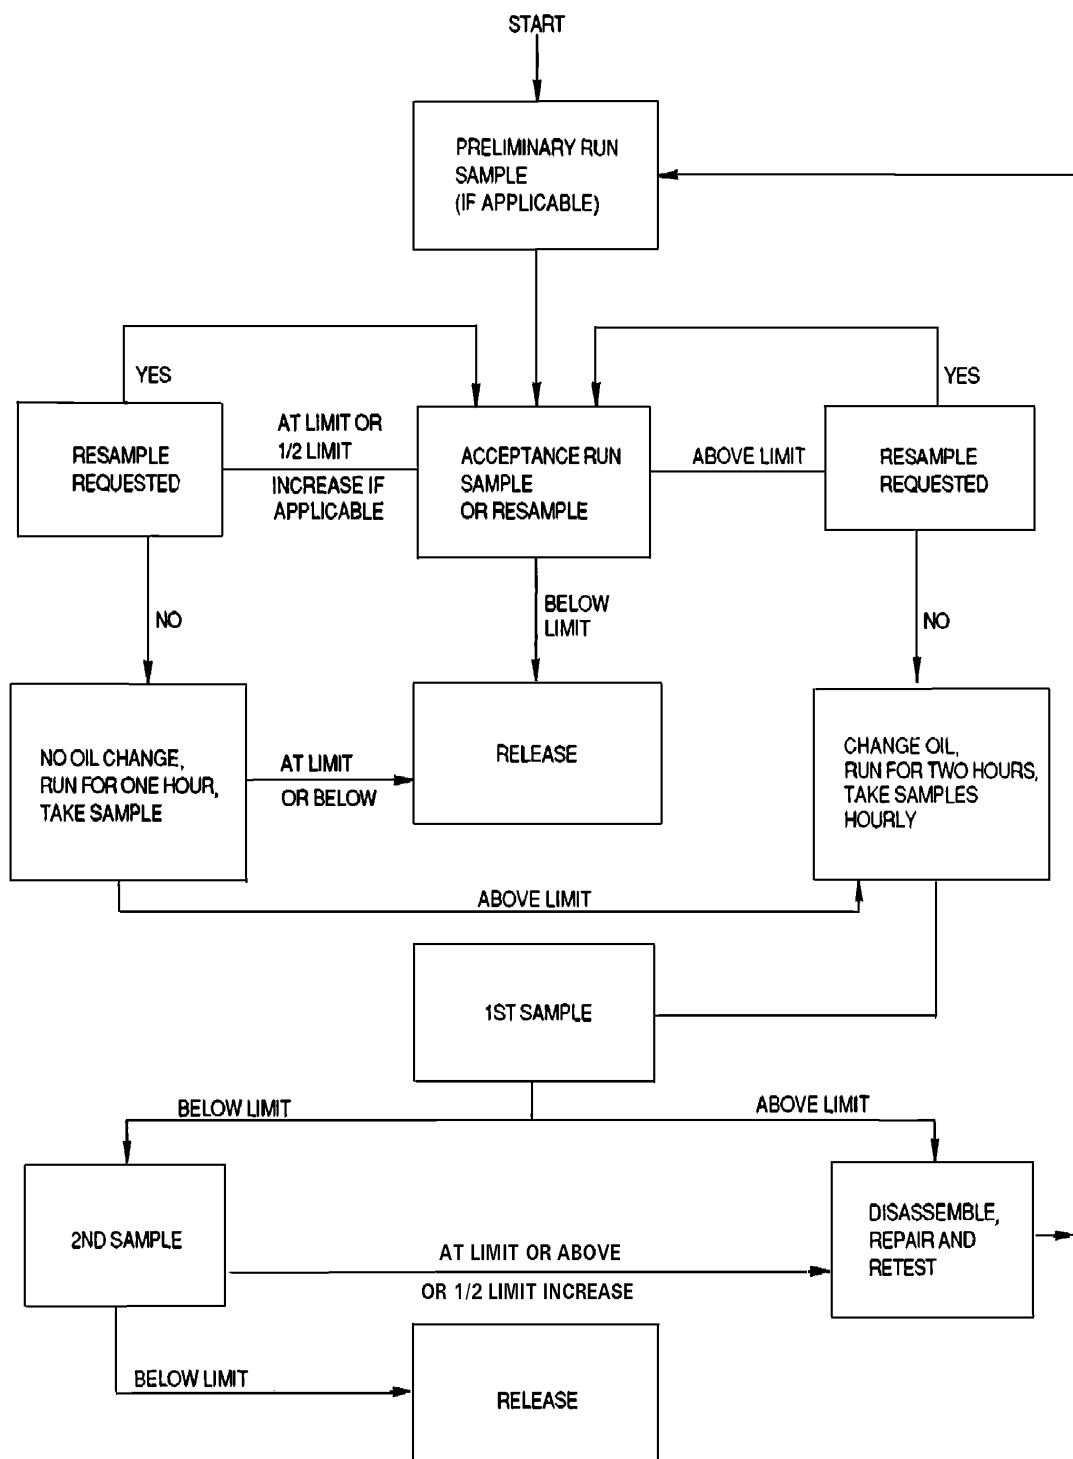
TABLE 2-4. AIR FORCE ALC DEPOT DECISION LOGIC

*DO NOT CHANGE OIL FOR T56 OR G56 AT ALC UNLESS REQUIRED

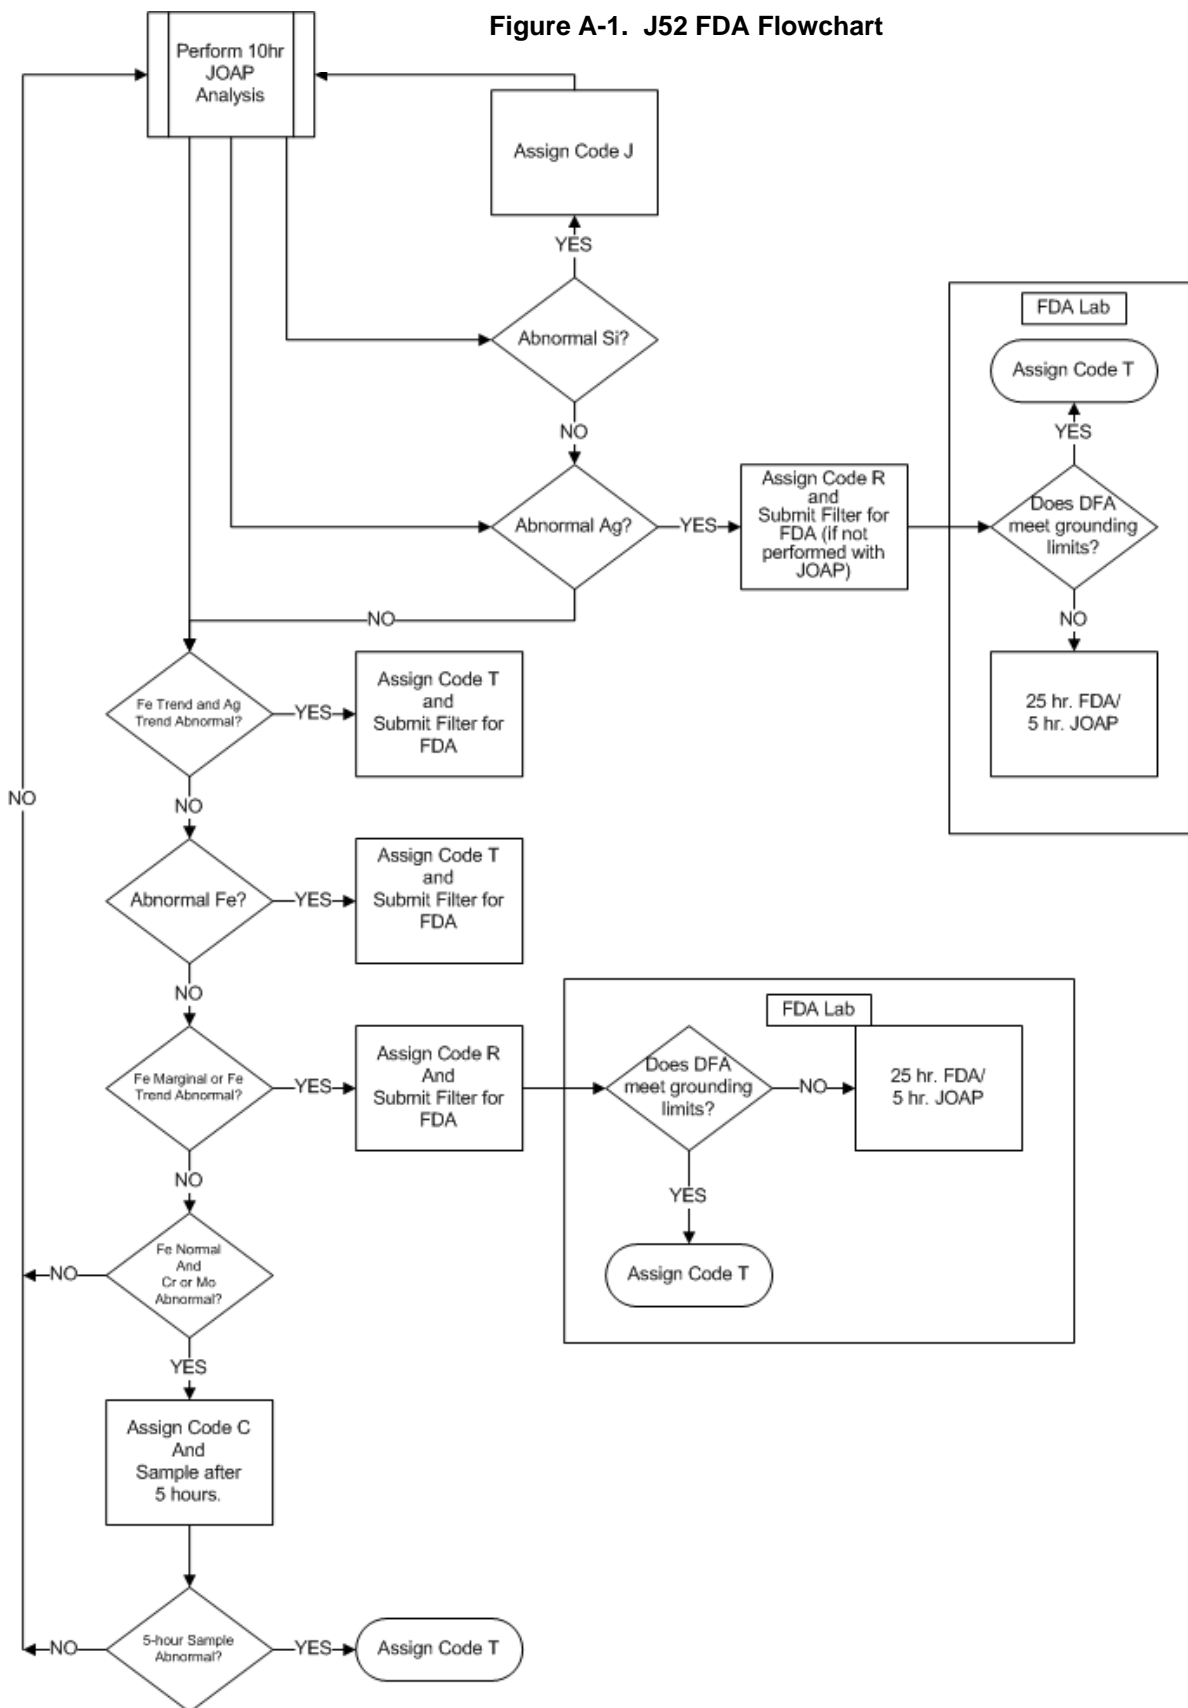
Figure A-1. J52 FDA Flowchart

1. If the FE is at or exceeds the abnormal limit, issue advice code T, do not fly or operate, recommend engine removal.
2. If the Fe trend and the Ag trend is at or exceeds the abnormal trend limit, issue advice code T, do not fly or operate, recommend engine removal.

3. If the Fe is in the high range or the trend for Fe meets or exceeds the table limit, recommendation shall be code R, do not fly or operate, inspect filter using FDA. If the FDA inspection meets grounding criteria, assign code T, do not fly or operate, recommend engine removal. If the FDA inspection does not meet grounding criteria, place filter on a 25 hour cycle, place JOAP oil sampling on a 5 hour interval until results return to normal.

4. If Cr and/or Mo are abnormal and the Fe is in the normal range, recommend code C, resample after 5 hours, do not change oil. If the resample is abnormal, assign code T, do not fly or operate, recommend engine removal.

5. If Ag is abnormal, recommend code R, do not fly or operate, inspect filter using FDA. If the FDA inspection meets grounding criteria, assign code T, do not fly or operate, recommend engine removal. If the FDA inspection does not meet grounding criteria, place filter on a 25 hour cycle, place JOAP oil sampling on a 5 hour interval until results return to normal.

6. IF Si is abnormal, recommend code J, contamination confirmed, change oil, resample with normal sampling schedule.

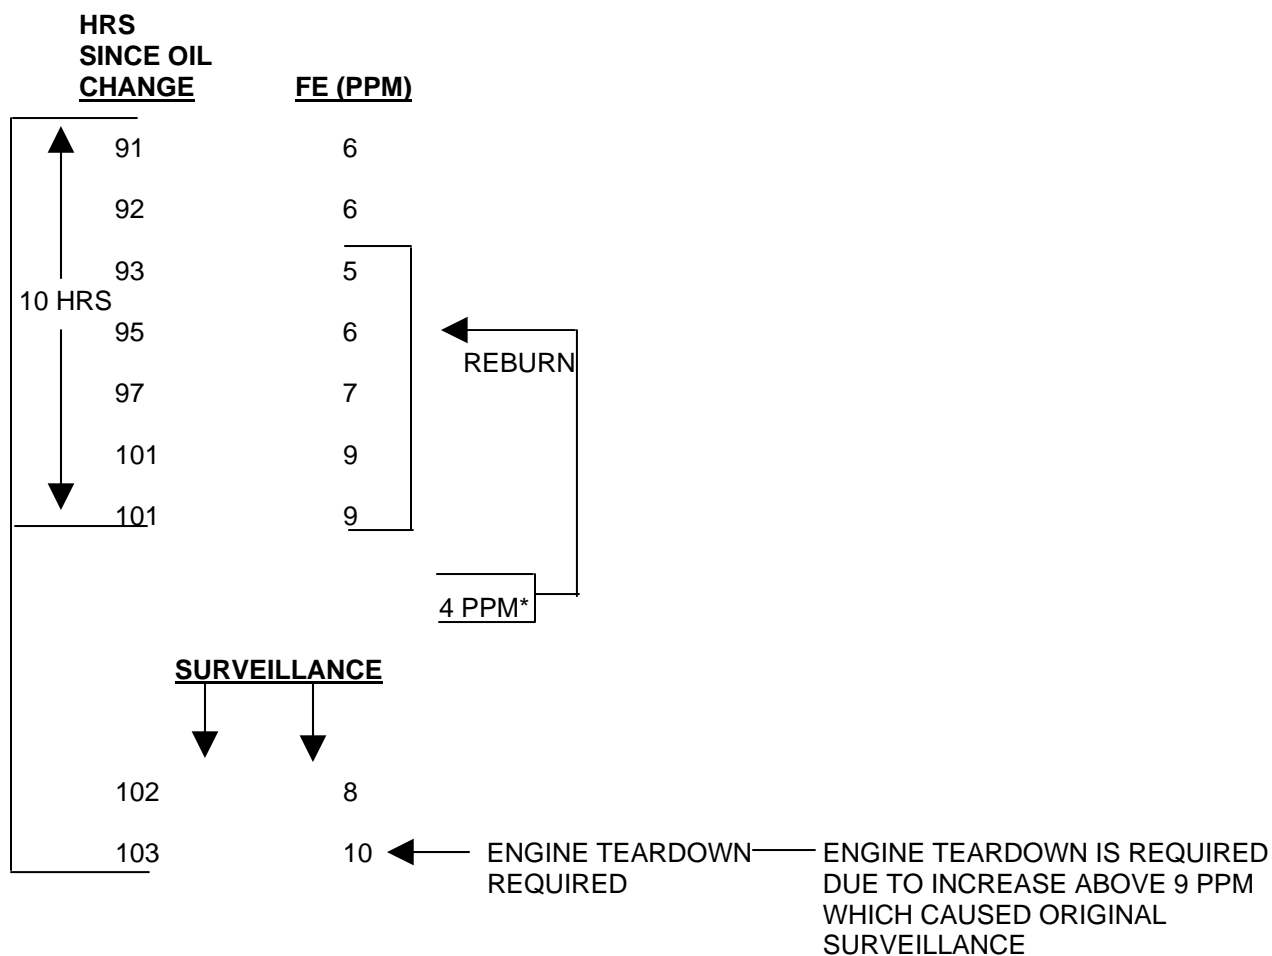
EXAMPLE: PRIOR TO SURVEILLANCE
 (FOR FE INCREASE IN 10 ENGINE HOURS)

JOAP RECORD ACTION REQUIRED REASON

* 4 PPM or greater using JOAP Atomic Emission.

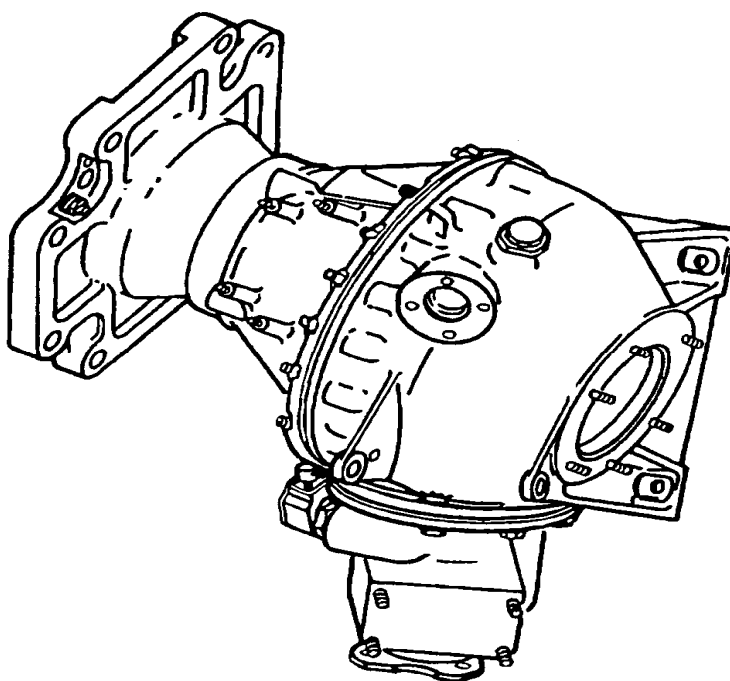
Figure A-2. Tail Rotor Gearbox

UH-60A, UH-60L, UH-60M, EH-60A, (Cont.)
EH-60L, HH-60A, HH-60L, MH-60K,
MH-60L, MH-60M, BLACK HAWK (ARMY)
TAIL ROTOR GEARBOX

3. Oil analysis lab personnel may receive oil samples either from a regular interval sampling, or whenever the field unit experiences a problem with the tail rotor gearbox on their aircraft. The regular sampling interval is 40 flight hours. The most common cause for field units to send a special sample to the oil analysis laboratory is when there are chips present in the gearbox. Table A-1 gives the chip evaluation criteria for tail rotor gearboxes. These criteria may be used by laboratory personnel to assist in the evaluation of the condition of a tail rotor gearbox from which chips were identified.

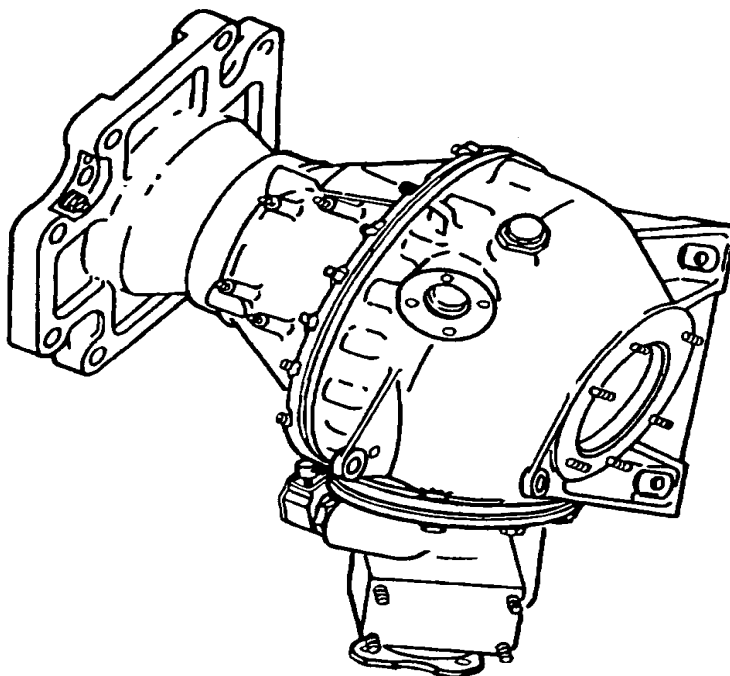
Figure A-5. Tail Rotor Gearbox

VH-60N (Cont.)
TAIL GEARBOX

4. All oil samples submitted for analysis should be checked for water contamination. The limit is 1200 PPM or 0.120%. Gearboxes with water contamination should be drained and flushed per paragraph 7 below in an attempt to prevent gearbox housing corrosion. See paragraph 6b for further information.
